DELAWARE RIVER BASIN
POND RUN, MERCER COUNTY
NEW JERSEY

ASSUNPINK W.S. SITE
NO. 8 DAM
PHASE I INSPECTION REPORT
NATIONAL DAM SAFETY PROGRAM

NJ 00543

NAME OF DAM: ASSUNPINK W.S. SITE NO. 8

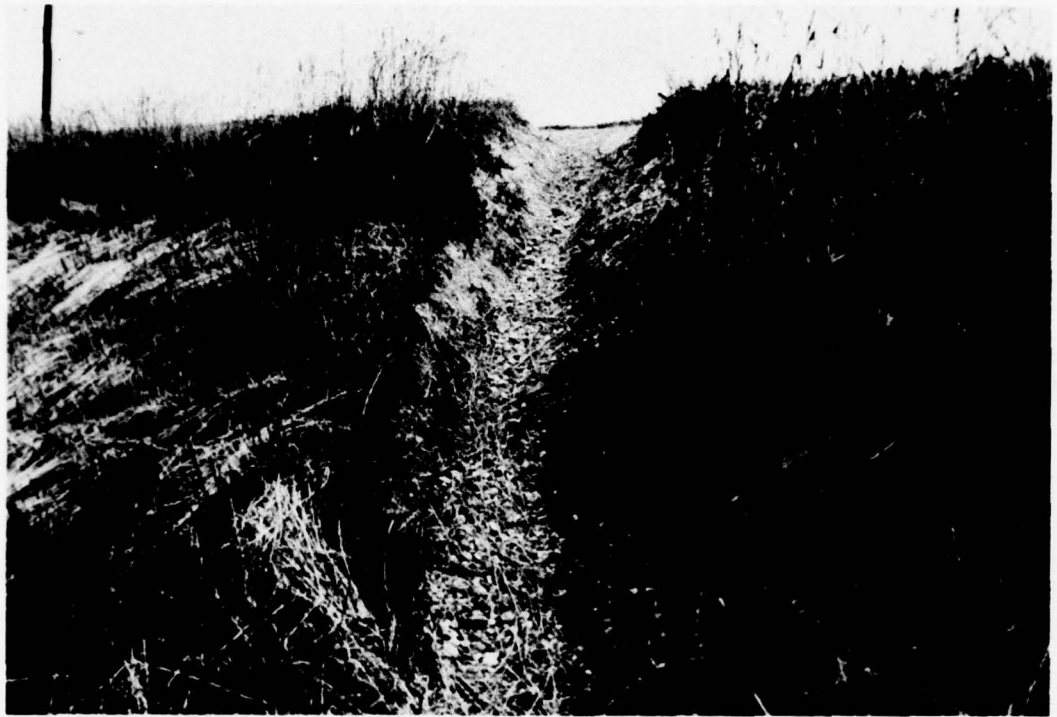
PHOTO 1

Photo 1 - Gully Erosion of Downstream Slope Near Left Abutment - 23 June 1978

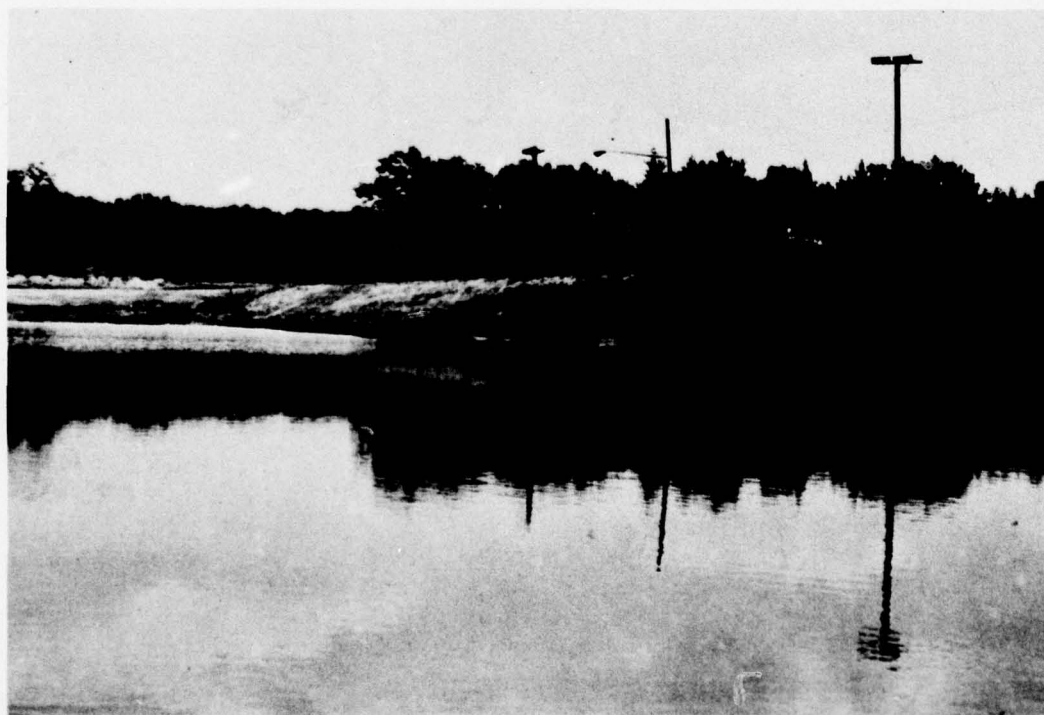
PHOTO 4

Photo 4 - View of Upstream Embankment Slope and Riser - 23 June 1978

(8) On the upstream side of the dam, areas of slight wave erosion above the bench and the area of slight surface sloughage near the riser should be repaired and reseeded.

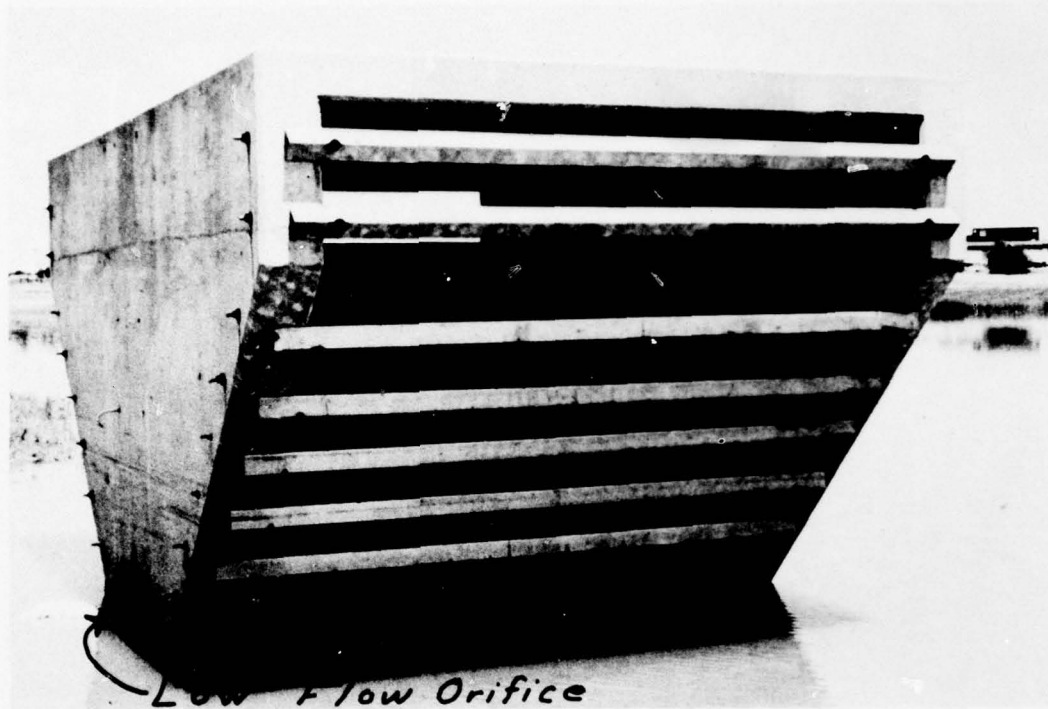
PHOTO 5

Photo 5 - Closer View of Riser Showing Debris Against Low Pool Orifice and Trash Rack (Note that low pool orifice trash rack is missing.) - 23 June 1978
